Flood Control Project Maintenance
2018 Structure Summary Report
Overall Unit and Item Ratings

DWR Sacramento Maintenance Yard

Cache Creek Settling Basin Weir And Drainage Structure

Flood Control Project Maintenance
Unit Cover Sheet
2018 Structure Inspection Results

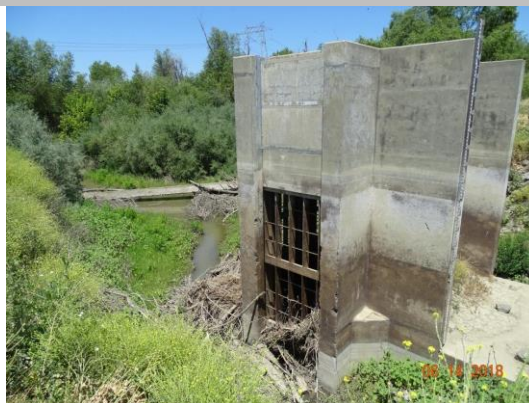
Photo 1 of 4 : ST_2018_NA0055_12_24_20180614_00018.jpg

LM Start	0.00	Rating **	N	Issue No.	24
LM End	0.00	Issue Type +	Ma	Location *	CR
Category	Structures & Concrete Lined Channels			GPS Latitude/Longitude	
				Start	End
Item	Photo Documentation			38.682438°	38.687317°
				-121.672924°	-121.673711°
DWR ID	DWR_NA0055_12_t_2012_24				
Action/Comments					
Inspector Comments: View of the drainage structure at the inlet and outlet locations.

View of the inlet structure at the south end of the weir. Summer 2018.

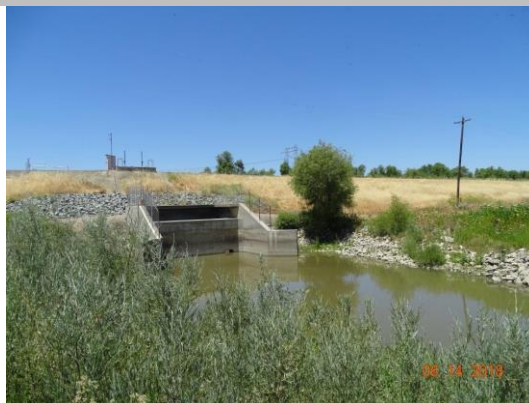
Photo 2 of 4 : ST_2018_NA0055_12_24_20180614_00021.jpg

View of the outlet structure at the south end of the weir. Summer 2018.

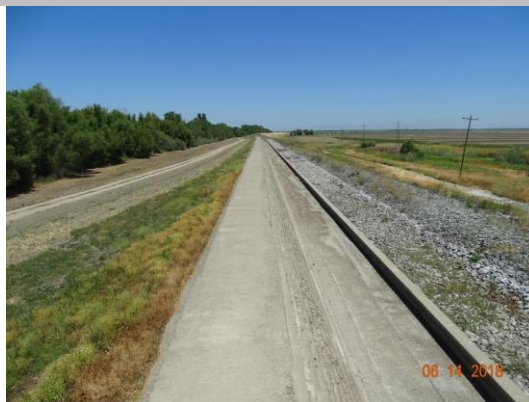
Photo 3 of 4 : ST_2018_NA0055_12_24_20180614_00023.jpg

View of the weir from the south end, looking north. Summer 2018.

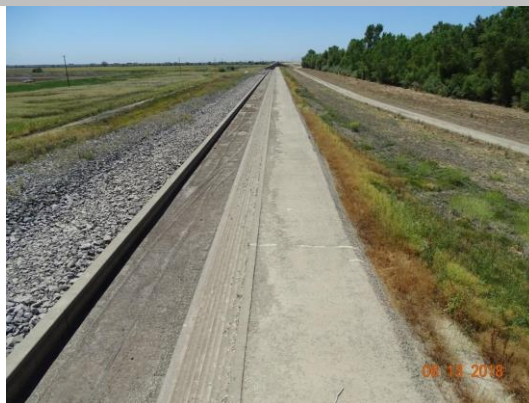
Photo 4 of 4 : ST_2018_NA0055_12_24_20180614_00022.jpg

View of the weir from the north end, looking south. Summer 2018.

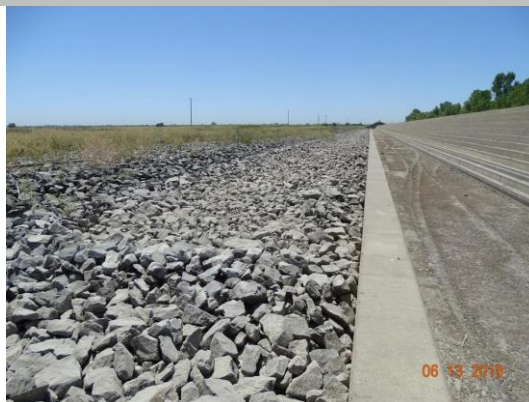
Photo 1 of 2 : ST_2018_NA0055_12_5_20180614_00011.jpg

LM Start	0.00	Rating **	A	Issue No.	5
LM End	0.00	Issue Type +	Ma	Location *	CR
Category	Structures & Concrete Lined Channels			GPS Latitude/Longitude	
				Start	End
Item	Revetments			38.682460 °	38.687350 °
				-121.672930 °	-121.673740 °
DWR ID	DWR_NA0055_12_t_2012_5				
Action/Comments					
Inspector Comments: Existing riprap protection is properly maintained. Riprap is clearly visible and undamaged.

View of revetments looking north. Summer 2018.

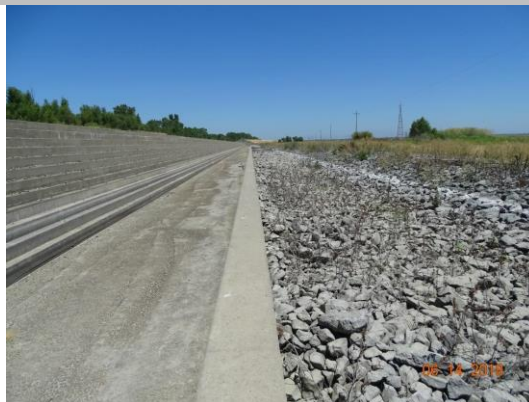
Photo 2 of 2 : ST_2018_NA0055_12_5_20180614_00012.jpg

View of revetments looking south. Summer 2018.

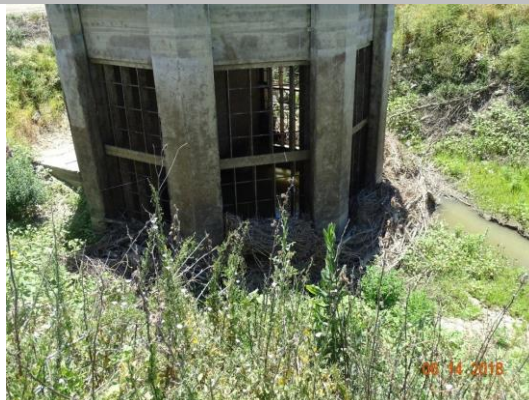
Photo 1 of 2 : ST_2018_NA0055_12_7_20180614_00013.jpg

LM Start	0.00	Rating **	M	Issue No.	7
LM End	0.00	Issue Type +	Ma	Location *	CR
Category	Structures & Concrete Lined Channels			GPS Latitude/Longitude	
				Start	End
Item	Culverts: Inlets / Outlets			38.682460 °	38.687350 °
				-121.672930 °	-121.673740 °
DWR ID	DWR_NA0055_12_t_2012_7				
Action/Comments					
Inspector Comments: Some debris partially blocking drainage inlet within Cache Creek Settling Basin.

View of inlet structure at Cache Creek Settling Basin. Summer 2018.

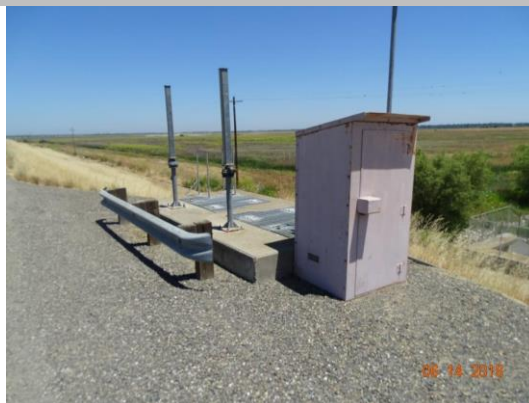
Photo 1 of 1 : ST_2018_NA0055_12_14_20180614_00016.jpg

LM Start	0.00	Rating **	A	Issue No.	14
LM End	0.00	Issue Type +	Ma	Location *	CR
Category	Structures & Concrete Lined Channels	GPS Latitude/Longitude			
		Start		End	
Item	Manual Gate Operators	38.682460 °		38.687350 °	
		-121.672930 °		-121.673740 °	
DWR ID	DWR_NA0055_12_t_2012_14				
Action/Comments					
Inspector Comments: The gates are tested once a year with safety of dams.

View of the gate operators to the drainage structure. Summer 2018.

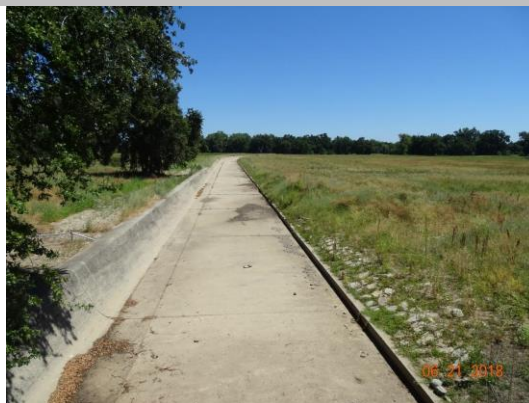
Photo 1 of 11 : ST_2018_NA0055_2_24_20180625_00037.jpg

View of the weir from the west abutment, facing northeast. Summer 2018.

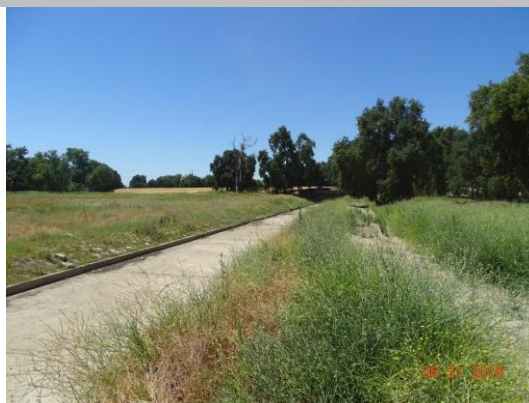
Photo 2 of 11 : ST_2018_NA0055_2_24_20180625_00035.jpg

View of the weir facing the west abutment. Summer 2018.

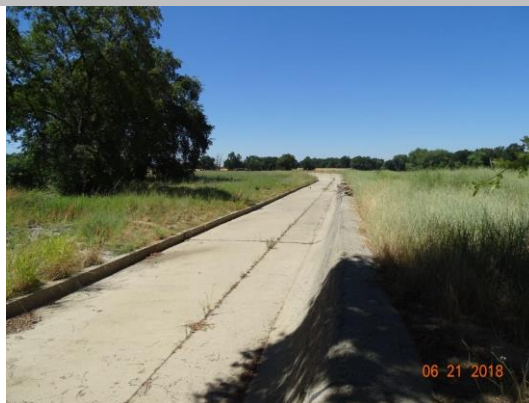
Photo 3 of 11 : ST_2018_NA0055_2_24_20180625_00030.jpg

View of the weir near the midpoint, facing southwest. Summer 2018.

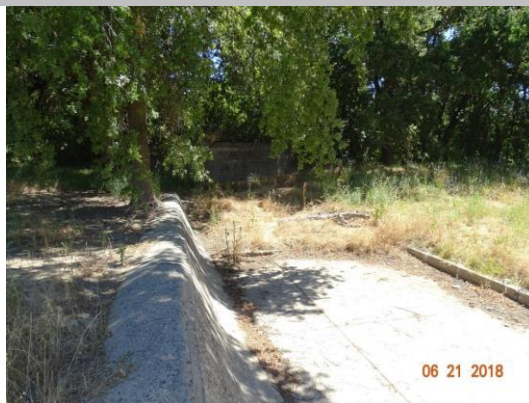
Photo 4 of 11 : ST_2018_NA0055_2_24_20180625_00031.jpg

View of the weir midpoint. Summer 2018.

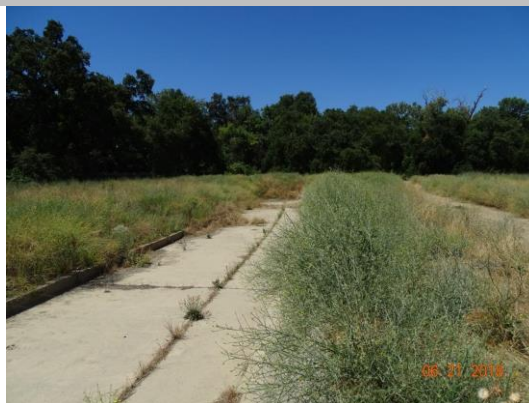
Photo 5 of 11 : ST_2018_NA0055_2_24_20180625_00029.jpg

View of the weir facing southwest towards the midpoint. Summer 2018.

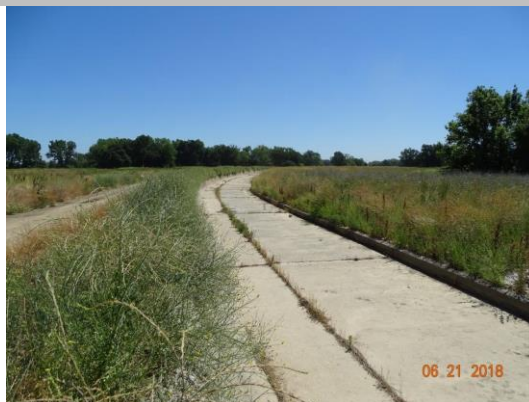
Photo 6 of 11 : ST_2018_NA0055_2_24_20180625_00028.jpg

View of the weir facing northeast from the midpoint. Summer 2018.

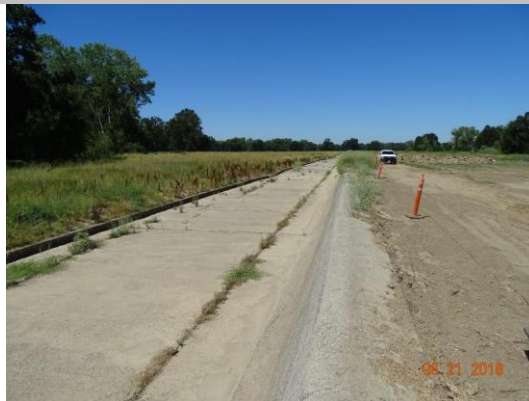
Photo 7 of 11 : ST_2018_NA0055_2_24_20180625_00027.jpg

View of the weir from the fish passageway, facing west. Summer 2018.

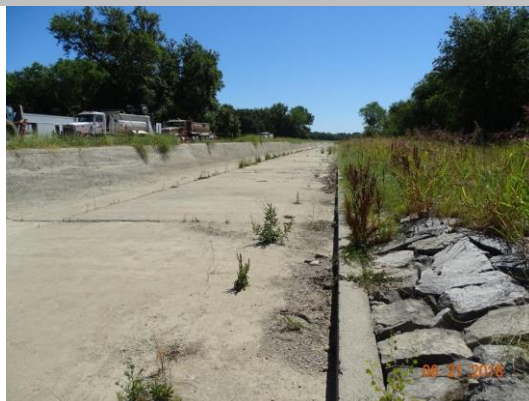
Photo 8 of 11 : ST_2018_NA0055_2_24_20180625_00026.jpg

View of the weir from the fish passageway, facing east. Summer 2018.

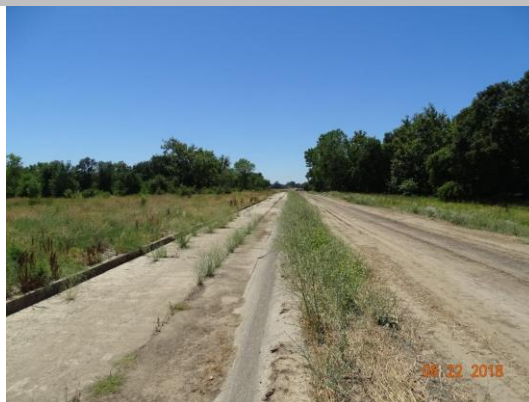
Photo 9 of 11 : ST_2018_NA0055_2_24_20180625_00040.jpg

View of the weir facing west, near east abutment. Summer 2018.

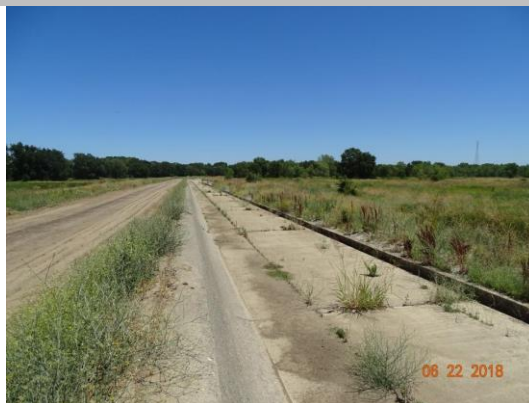
Photo 10 of 11 : ST_2018_NA0055_2_24_20180625_00042.jpg

View of the weir facing towards east abutment. Summer 2018.

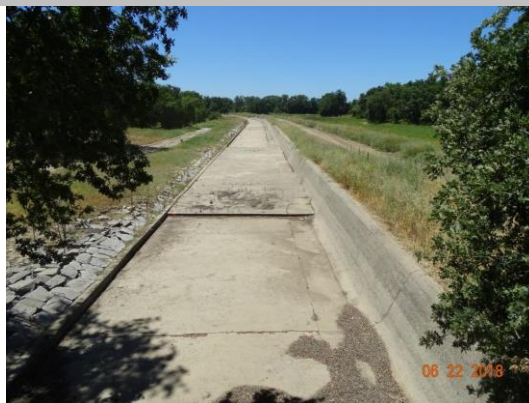
Photo 11 of 11 : ST_2018_NA0055_2_24_20180625_00043.jpg

View of the weir from the east abutment. Summer 2018.

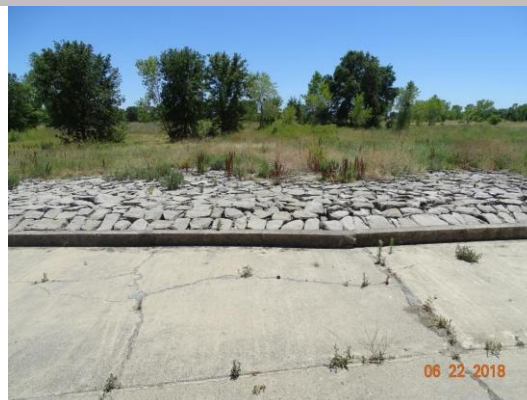
Photo 1 of 1 : ST_2018_NA0055_2_5_20180625_00014.jpg

LM Start	0.00	Rating **	A	Issue No.	5
LM End	0.00	Issue Type +	Ma	Location *	CR
Category	Structures & Concrete Lined Channels			GPS Latitude/Longitude	
				Start	End
Item	Revetments			38.758880 °	38.764680 °
				-121.665380 °	-121.635430 °
DWR ID	DWR_NA0055_2_t_2012_5				
Action/Comments					
Inspector Comments: No riprap displacement or scouring activity that could undercut banks, erode embankments, or restrict desired flow. Unwanted vegetation must be cleared and sprayed with an appropriate herbicide.

View of revetment along weir. Summer 2018.

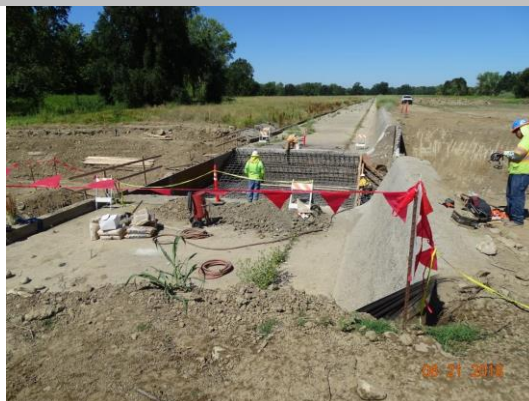
Photo 2 of 7 : ST_2018_NA0055_2_15_20180625_00021.jpg

LM Start	0.00	Rating **	A	Issue No.	15
LM End	0.00	Issue Type +	Ma	Location *	CR
Category	Structures & Concrete Lined Channels			GPS Latitude/Longitude	
				Start	End
Item	Concrete Surfaces			38.758880 °	38.764680 °
				-121.665380 °	-121.635430 °
DWR ID	DWR_NA0055_2_t_2012_15				
Action/Comments					
Inspector Comments: Large crack on the west weir abutment. A new fish passageway within the weir is being constructed. The fish ladder has been removed.

View of demoed weir section and rebar cage for new fish passage structure. Summer 2018.

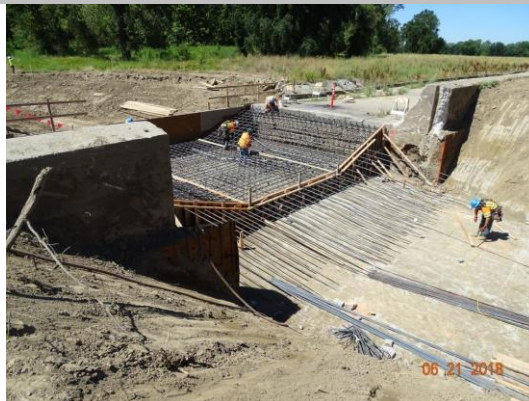
Photo 3 of 7 : ST_2018_NA0055_2_15_20180625_00022.jpg

View of rebar cage installation. Summer 2018.

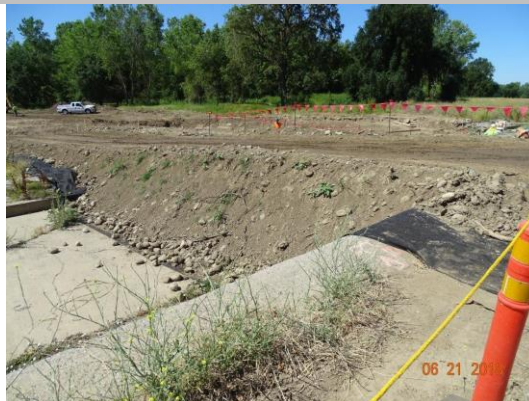
Photo 4 of 7 : ST_2018_NA0055_2_15_20180625_00016.jpg

LM Start	0.00	Rating **	A	Issue No.	15 (cont)
LM End	0.00	Issue Type +	Ma	Location *	CR
Category	Structures & Concrete Lined Channels	GPS Latitude/Longitude			
		Start		End	
Item	Concrete Surfaces	38.758880 °		38.764680 °	
		-121.665380 °		-121.635430 °	
DWR ID	DWR_NA0055_2_t_2012_15				
Action/Comments					
Inspector Comments: Large crack on the west weir abutment. A new fish passageway within the weir is being constructed. The fish ladder has been removed.

View of temporary crossing over existing weir. Summer 2018.

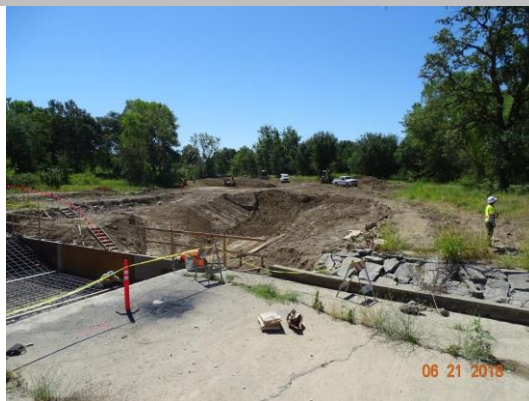
Photo 5 of 7 : ST_2018_NA0055_2_15_20180625_00019.jpg

Upstream view of fish passageway. Summer 2018.

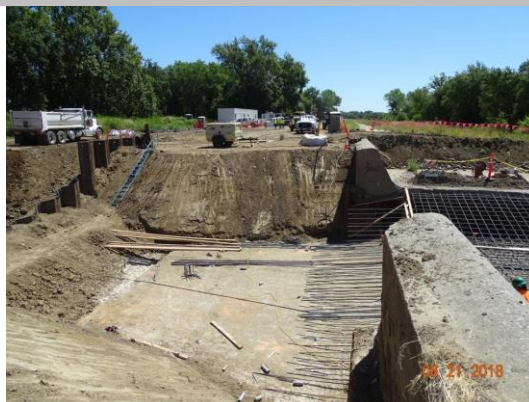
Photo 6 of 7 : ST_2018_NA0055_2_15_20180625_00024.jpg

View of fish passageway excavation. Summer 2018.

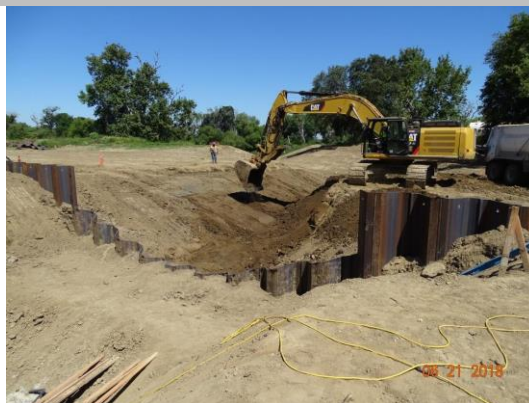
Photo 7 of 7 : ST_2018_NA0055_2_15_20180625_00025.jpg

Downstream view of fish passageway from weir. Summer 2018.

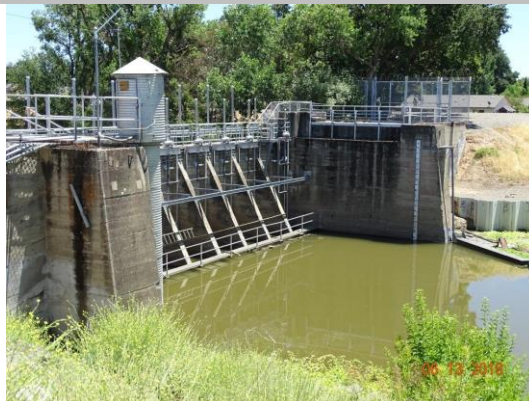
Photo 1 of 2 : ST_2018_NA0055_41_1_20180612_00009.jpg

View of the inlet side of the structure. Summer 2018.

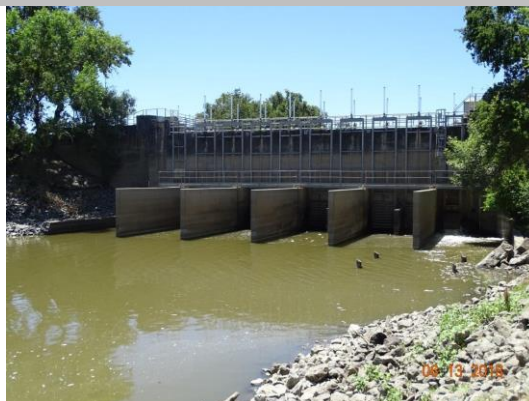
Photo 2 of 2 : ST_2018_NA0055_41_1_20180612_00010.jpg

View of the outlet side of the structure. Summer 2018.

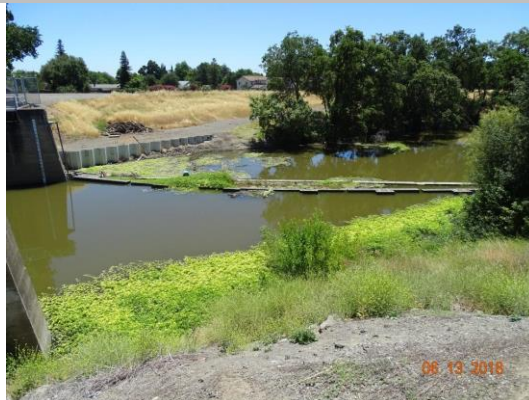
Photo 1 of 3 : ST_2018_NA0055_41_2_20180612_00011.jpg

LM Start	0.00	Rating **	A	Issue No.	2
LM End	0.00	Issue Type +	Ma	Location *	
Category	Structures & Concrete Lined Channels			GPS Latitude/Longitude	
				Start	End
Item	Vegetation & Obstructions			38.799560 °	38.799320 °
				-121.725530 °	-121.724850 °
DWR ID	DWR_NA0055_41_t_2012_2				
Action/Comments					
Inspector Comments: Minimal, scattered obstructions or vegetation. The flow is not impeded.

View of the channel looking towards the right bank. Summer 2018.

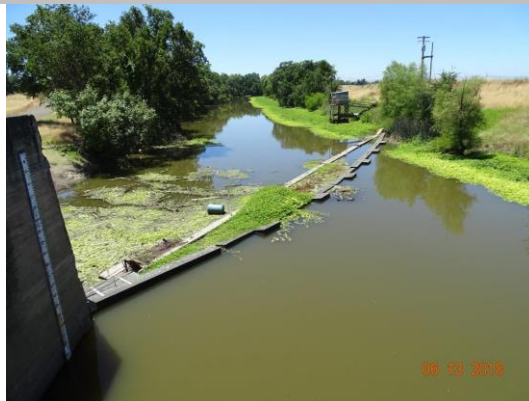
Photo 2 of 3 : ST_2018_NA0055_41_2_20180612_00013.jpg

View of the channel looking upstream. Summer 2018.

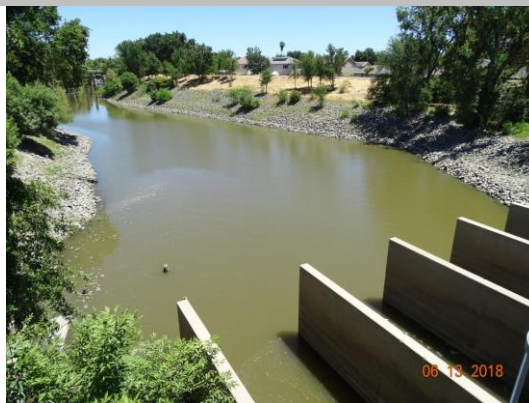
Photo 3 of 3 : ST_2018_NA0055_41_2_20180612_00012.jpg

View of the channel looking downstream from the structure. Summer 2018.

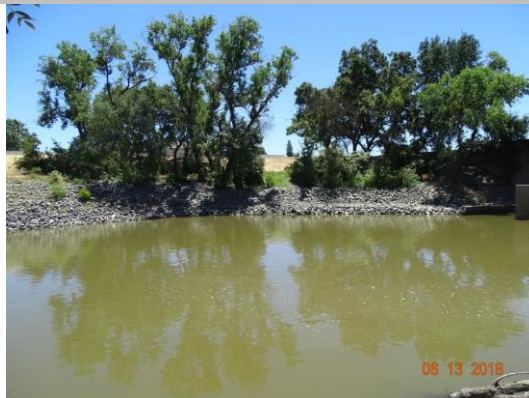
Photo 1 of 2 : ST_2018_NA0055_41_5_20180612_00014.jpg

LM Start	0.00	Rating **	A	Issue No.	5
LM End	0.00	Issue Type +	Ma	Location *	
Category	Structures & Concrete Lined Channels			GPS Latitude/Longitude	
				Start	End
Item	Revetments			38.799560 °	38.799320 °
				-121.725530 °	-121.724850 °
DWR ID	DWR_NA0055_41_t_2012_5				
Action/Comments					
Inspector Comments: Existing riprap protection is properly maintained and is undamaged. Riprap clearly visible.

View of rip rap on the left bank downstream of the outlet. Summer 2018.

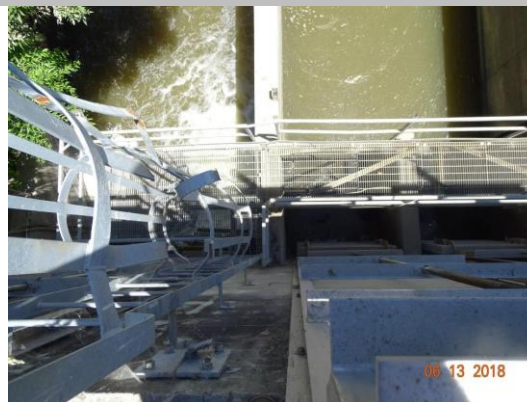
Photo 1 of 1 : ST_2018_NA0055_41_11_20180613_00016.jpg

LM Start	0.00	Rating **	A	Issue No.	11
LM End	0.00	Issue Type +	Ma	Location *	
Category	Structures & Concrete Lined Channels	GPS Latitude/Longitude			
		Start	End		
Item	Flap Gates	38.799560 °		38.799320 °	
		-121.725530 °		-121.724850 °	
DWR ID	DWR_NA0055_41_t_2012_11				
Action/Comments					
Inspector Comments: Flap gates open and close easily with minimal leakage. Gates show no corrosion damage and have been maintained.

View of semi-opened flap gate and closed gates at the structure outlet. Summer 2018.

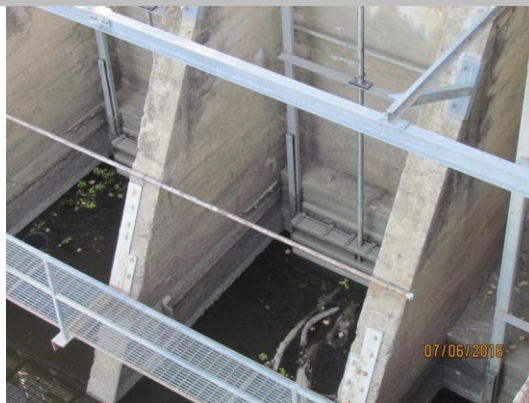
Photo 1 of 1 : ST_2018_NA0055_41_12_20180612_00006.jpg

LM Start	0.00	Rating **	A	Issue No.	12
LM End	0.00	Issue Type +	Ma	Location *	
Category	Structures & Concrete Lined Channels			GPS Latitude/Longitude	
				Start	End
Item	Sluice/Slide Gates			38.799560 °	38.799320 °
				-121.725530 °	-121.724850 °
DWR ID	DWR_NA0055_41_t_2012_12				
Action/Comments					
Inspector Comments: Gates open and close freely with minor leakage. Sill is free of sediment and other obstructions. Gates and lifters have been maintained.

View of the unopened slide gate on the inlet side of the structure. Summer 2016.

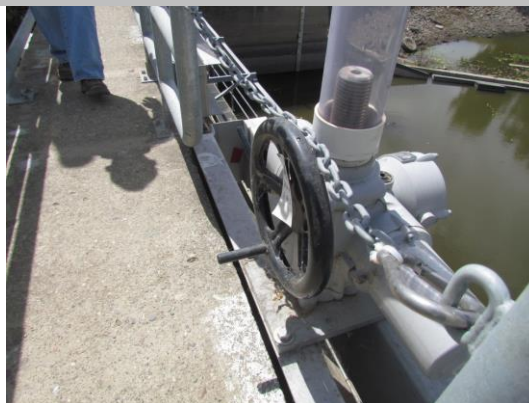
Photo 1 of 2 : ST_2018_NA0055_41_14_20180612_00007.jpg

LM Start	0.00	Rating **	A	Issue No.	14
LM End	0.00	Issue Type +	Ma	Location *	
Category	Structures & Concrete Lined Channels			GPS Latitude/Longitude	
				Start	End
Item	Manual Gate Operators			38.799560 °	38.799320 °
				-121.725530 °	-121.724850 °
DWR ID	DWR_NA0055_41_t_2012_14				
Action/Comments					
Inspector Comments: The manual gates appear to be operational.

Close-up view of the wheel for the flap gate. Summer 2015.

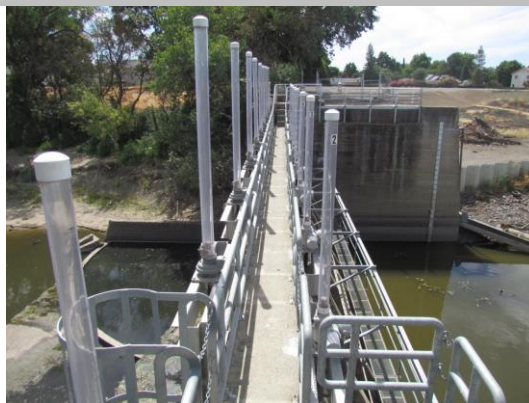
Photo 2 of 2 : ST_2018_NA0055_41_14_20180612_00008.jpg

LM Start	0.00	Rating **	A	Issue No.	14 (cont)	
LM End	0.00	Issue Type +	Ma	Location *		
Category	Structures & Concrete Lined Channels			GPS Latitude/Longitude		
				Start	End	
Item	Manual Gate Operators			38.799560 °	38.799320 °	
				-121.725530 °	-121.724850 °	
DWR ID	DWR_NA0055_41_t_2012_14					
Action/Comments						
Inspector Comments: The manual gates appear to be operational.

View of the control structure to manually close the flap gates. Summer 2015.

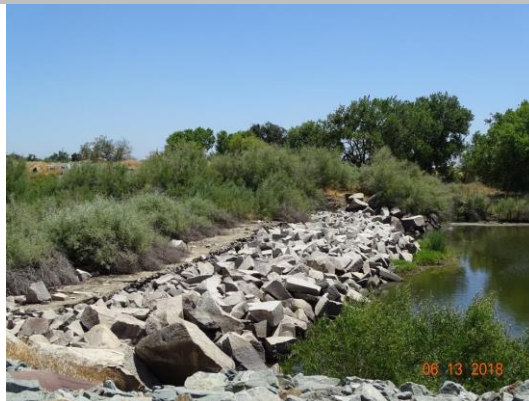
Photo 1 of 4 : ST_2018_NA0055_52_24_20180618_00015.jpg

View of Paradise Dam from the right bank of Paradise Cut. Summer 2018

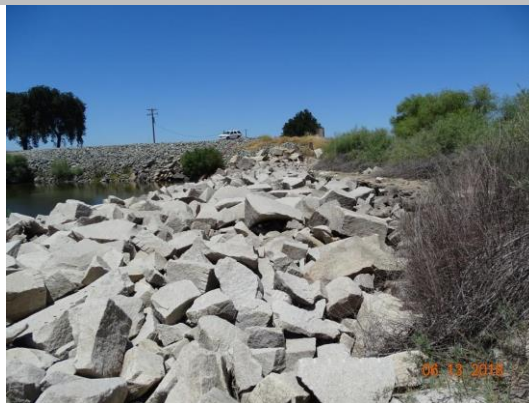
Photo 2 of 4 : ST_2018_NA0055_52_24_20180618_00016.jpg

Looking towards north end of Paradise Dam. Summer 2018

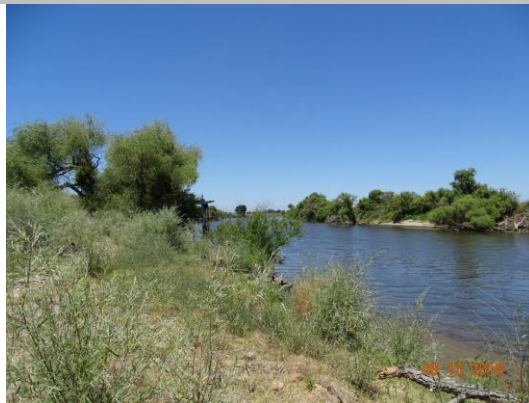
Photo 3 of 4 : ST_2018_NA0055_52_24_20180618_00014.jpg

Looking downstream on the San Joaquin River, from Paradise Dam inlet. Summer 2018

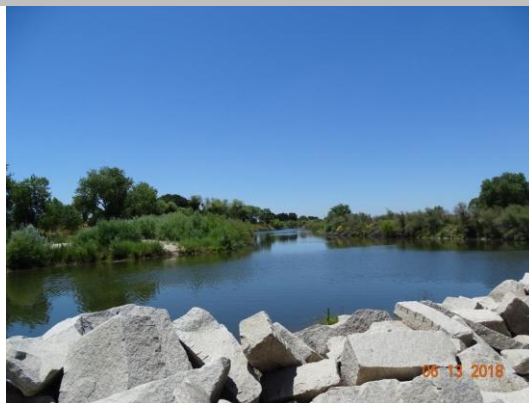
Photo 4 of 4 : ST_2018_NA0055_52_24_20180618_00013.jpg

Looking downstream at Paradise Cut from Paradise Dam inlet. Summer 2018

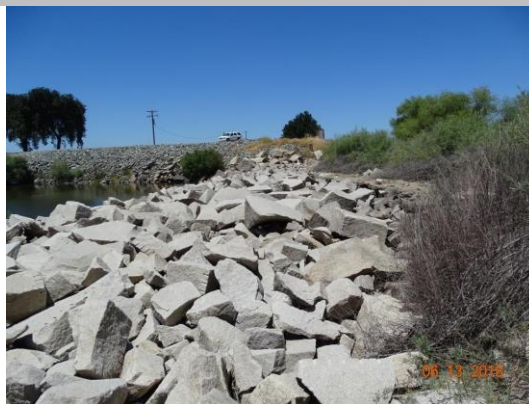
Photo 1 of 1 : ST_2018_NA0055_52_5_20180618_00012.jpg

LM Start	0.00	Rating **	A	Issue No.	5
LM End	0.00	Issue Type +	Ma	Location *	CR
Category	Structures & Concrete Lined Channels			GPS Latitude/Longitude	
				Start	End
Item	Revetments			37.760584 °	37.760584 °
				-121.309450 °	-121.309450 °
DWR ID	DWR_NA0055_52_t_2017_5				
Action/Comments					
Inspector Comments: Existing riprap protection is properly maintained and is undamaged. Riprap clearly visible.

View of riprap protection that is clearly visible

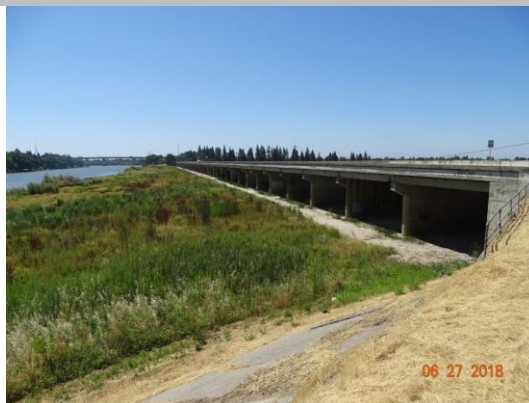
Photo 1 of 4 : ST_2018_NA0055_1_24_20180628_00027.jpg

View of weir inlet from the north end. Summer 2018.

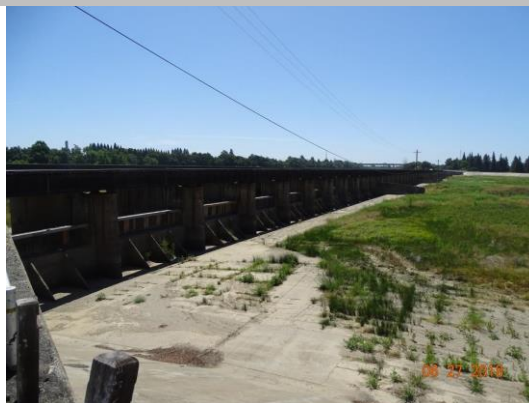
Photo 2 of 4 : ST_2018_NA0055_1_24_20180628_00028.jpg

View of weir outlet from the north end. Summer 2018.

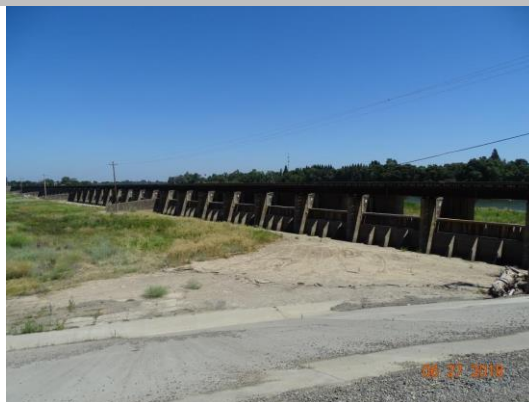
Photo 3 of 4 : ST_2018_NA0055_1_24_20180628_00029.jpg

View of the weir outlet from the south end. Summer 2018.

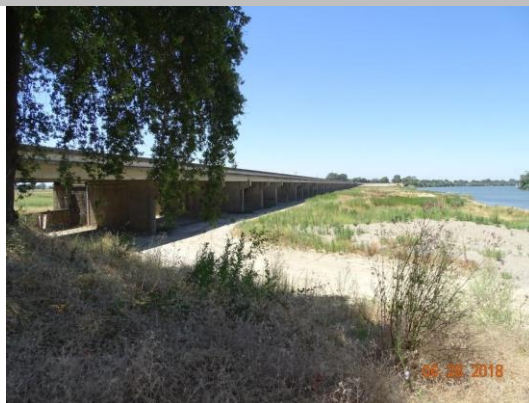
Photo 4 of 4 : ST_2018_NA0055_1_24_20180628_00030.jpg

View of the weir inlet from the south end. Summer 2018.

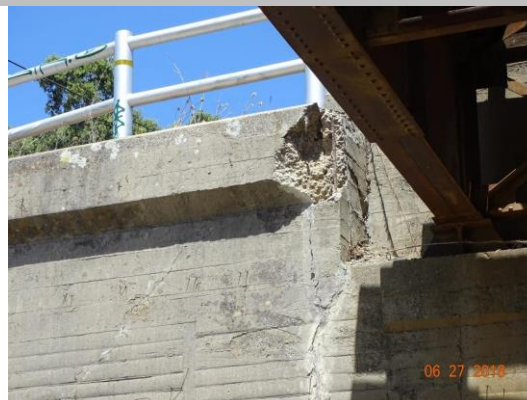
Photo 1 of 12 : ST_2018_NA0055_1_15_20180628_00014.jpg

LM Start	0.00	Rating **	M	Issue No.	15
LM End	0.00	Issue Type +	Ma	Location *	
Category	Structures & Concrete Lined Channels			GPS Latitude/Longitude	
				Start	End
Item	Concrete Surfaces			38.607120 °	38.607120 °
				-121.560100 °	-121.560100 °
DWR ID	DWR_NA0055_1_t_2016_15				
Action/Comments					
Inspector Comments: Spalling and cracking present, but the immediate integrity or performance of the structure is not threatened. Reinforcing steel is exposed. Sacramento Maintenance has done a great job in repairing the concrete surfaces. Some minor repairs are left to be done.

View of the top corner of the north end of the weir, on the outlet side. Summer 2018.
